Pathology of severe coronary artery calcification treated with orbital atherectomy followed by balloon modification

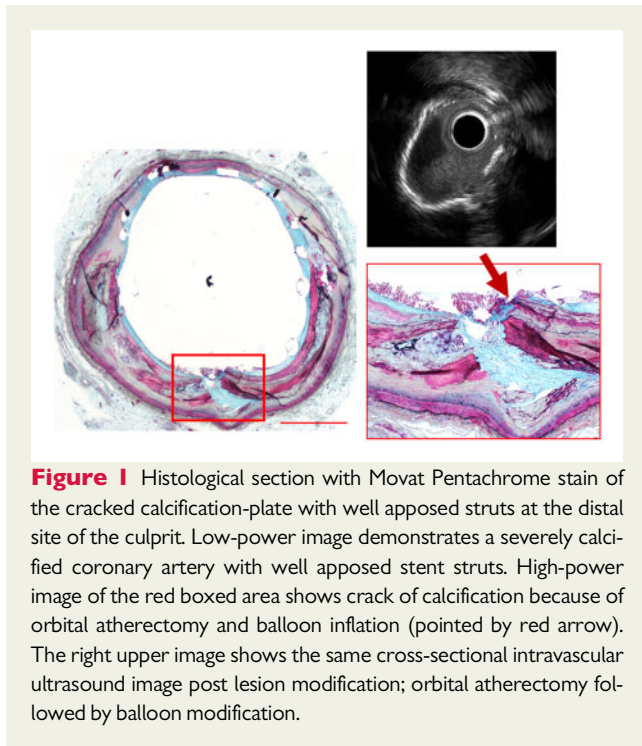
Figure 1 Histological section with Movat Pentachrome stain of the cracked calcification-plate with well apposed struts at the distal site of the culprit. Low-power image demonstrates a severely calcified coronary artery with well apposed stent struts. High-power image of the red boxed area shows crack of calcification because of orbital atherectomy and balloon inflation (pointed by red arrow). The right upper image shows the same cross-sectional intravascular ultrasound image post lesion modification; orbital atherectomy followed by balloon modification.

Pathological sections of the stented lesion showed an underlining sheet of calcium that was >1 mm thick with a circumferential distribution of >270°. The calcified lesion, in which OA was performed, was fragmented without ablation signs on its surface. The fragmented part

was completely separated into two pieces, resulting in good apposition (Figure 1). At the remaining malapposed strut in the snowman-like dilated site, a 270° sheet calcification showed recoil without the calcium cracking (Figure 2). To the best of our knowledge, this is the first case report showing co-registered images of IVUS and histological sections, which demonstrate how OA works in severely calcified lesions. The histopathological examinations revealed calcification that was >1 mm thick circumferentially, suggesting that plain old balloon angioplasty alone and cutting balloons, cannot crack such lesions, as shown in a previous optical coherence tomography study.¹ In this case, the crown rotated and 'knocked' the plate-like calcification discontinuously, thereby breaking the thick calcification without a medial tear, which avoided restenosis.²

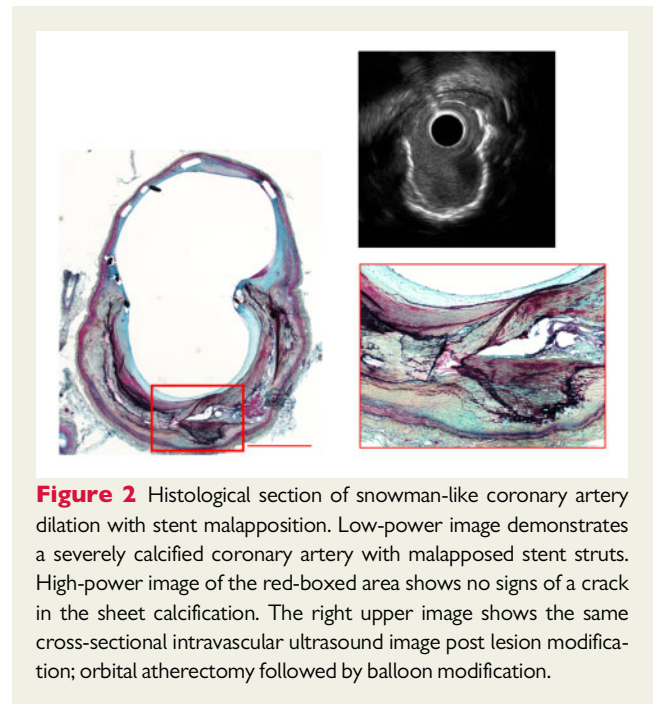
Figure 2 Histological section of snowman-like coronary artery dilation with stent malapposition. Low-power image demonstrates a severely calcified coronary artery with malapposed stent struts. High-power image of the red-boxed area shows no signs of a crack in the sheet calcification. The right upper image shows the same cross-sectional intravascular ultrasound image post lesion modification; orbital atherectomy followed by balloon modification.

balloon, followed by a 3-mm scoring balloon to dilate the lesion; both balloons were inflated at rated burst pressure; subsequently, a 3.5-mm newer-generation sirolimus-eluting stent was implanted. The final IVUS imaging examination performed after stent implantation showed snowman-like dilation with stent malapposition in the middle portion of the lesion. After 4 months, the patient died of pulmonary hypertension.

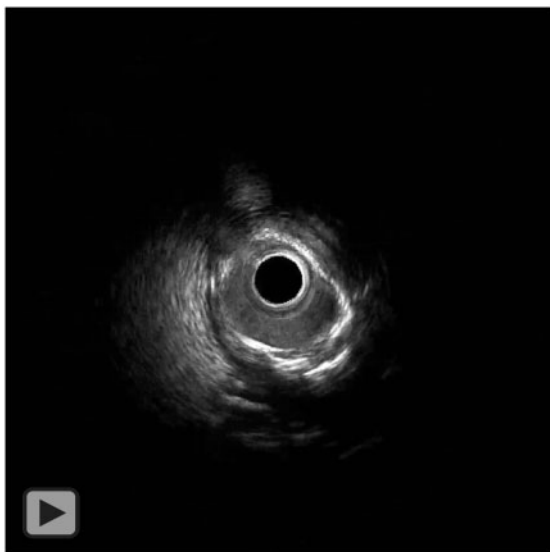
Video 1 Intravascular ultrasound before intervention.

Percutaneous coronary intervention was performed, and intravascular ultrasound (IVUS) imaging findings demonstrated a >270° calcification at the narrowest lesion. Three runs of low-speed retrograde orbital atherectomy (OA) were performed in the middle portion of the LAD with circumferential calcification. We used a 2.5-mm cutting

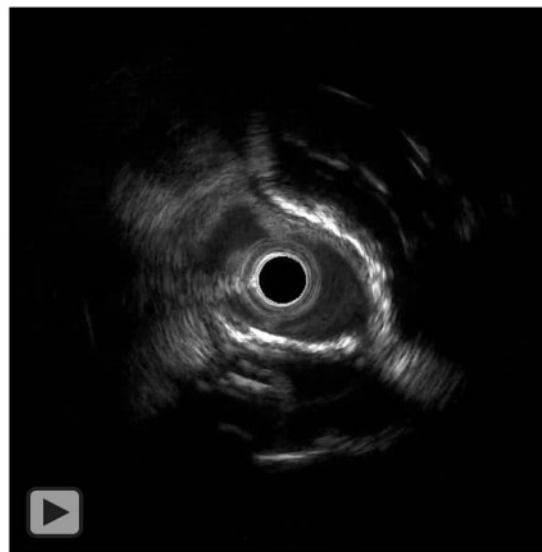
Video 3 Intravascular ultrasound after stent implantation.

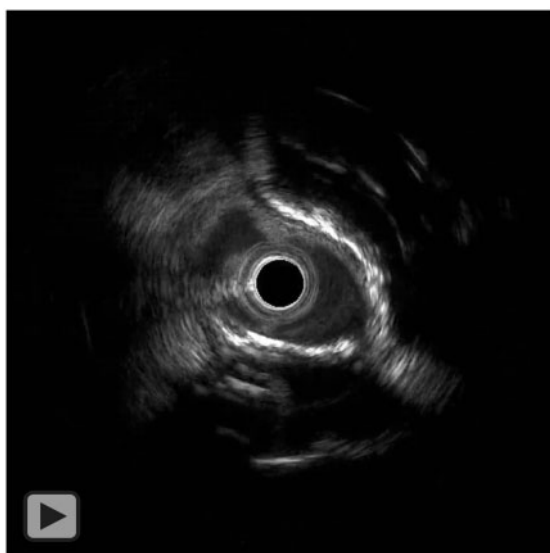
Video 2 Intravascular ultrasound after orbital atherectomy and cutting balloon inflation.
