Delayed distal migration of a balloon expandable valve-in-valve transcatheter aortic valve: a clinical case and review of the literature

Andrikopoulou E.; Kim AYK; Shook DCS; Sobieszczyk PSS; Pelletier MPP; Kaneko TK.; Shah PBS; Sun YPS

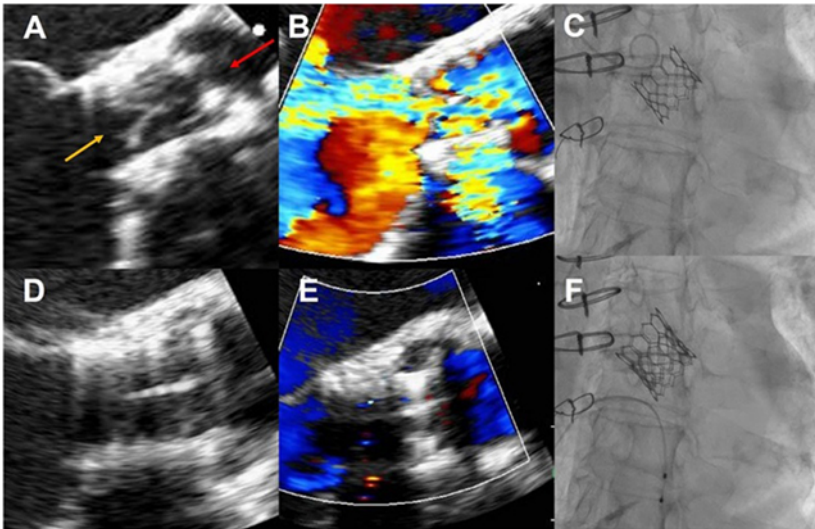
Abstract 499 Figure. TAVR migration:pre and post-intervention

Case Presentation: A 70 year old man presented with recurrent dyspnea and new decrease in his left ventricular ejection fraction 5 months following valve-in-valve (ViV) TAVR (26 mm). A TEE revealed migration of his ViV TAVR towards the left ventricular outflow tract (LVOT) with resultant severe paravalvular leak (Figure 1A, 1B, 1C; yellow arrow showing the TAVR, red arrow showing the previously implanted bioprosthetic surgical aortic valve). A 29 mm balloon expandable TAVR was placed and deployed higher to ensure anchoring of the device and adequate sealing of the area of paravalvular leak (Figure 1D, 1E, 1F). This resulted in resolution of regurgitation with an intraoperative transvalvular gradient of 10 mmHg. At his 3-month follow-up visit, a TTE showed a well-seated TAVR with mild paravalvular leak and a mean gradient of 17 mmHg. He successfully completed cardiac rehab and his dyspnea improved to mild.
