P702

An unusual echocardiographic finding of protrusive vegetation caused by perivalvular abscess perforation into the left atrium

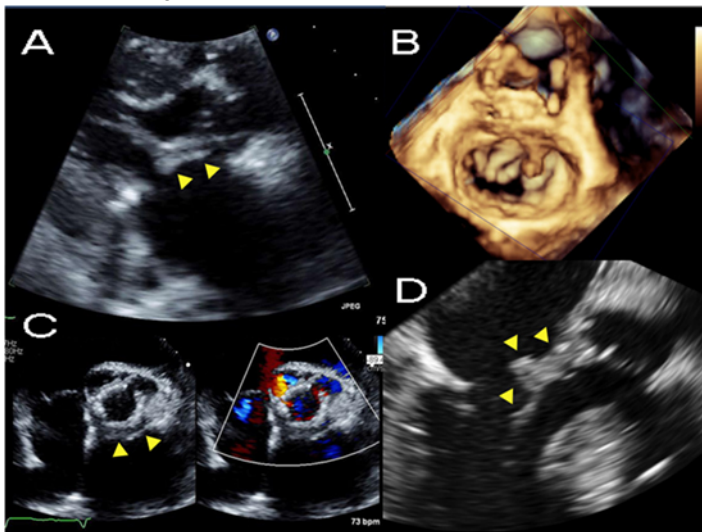
Abstract P702 Figure.

Conclusion: Early after the operation, TTE revealed a mass was protruded into the left atrium. Generally, vegetation is soft and flexible in itself. However, in this case, the vegetation was less mobile, and for that reason, abscesses or tumors were suspected. TEE enabled us to obtain anatomically more detailed information and to foresee the left atrial wall repairment at the time of reoperation. We reported an unusual case of IE with solid vegetation attached to the wall and difficult to diagnose.

Case report: A 77-year-old man underwent the bioprosthetic AVR for aortic valve stenosis one month ago. On the 9th day after discharge, he visited the hospital for the follow-up. At the time, the body temperature was 36.6 °C, the blood pressure 133/50 mmHg, white blood cell count 10500/ μ L, and C-reactive protein 3.31 mg/dL. Transthoracic echocardiography (TTE) demonstrated the perivalvular abscesses on the prosthetic aortic valve and mass structures attached to the MAIVF in the left atrium (Figure A, C). He was hospitalized again and had an emergency re-operation. Intraoperative transesophageal echocardiography (TEE) showed a perivalvular abscess on the prosthetic valve, and a high-intensity structure (vegetation like) protruding from the Valsalva Sinus into the left atrium of the MAIVF (Figure B, D). Surgical findings did not reveal any wart on the native valve itself. One-third of the annulus was disrupted. The subvalvular tissue all around was abscessed. Notably, the abscess cavity between NCC and LCC reached MAIVF of the anterior mitral leaflet, and the structure projecting to the left atrium was vegetation. In this case, TTE pointed out a perivalvular abscess of the aortic valve, IE was suspected at the time of outpatient visit at an early stage after discharge, and the spread of inflammation was observed with a high speed beyond the expectation at the time of operation.
